Raise the Stakes

M109A2-A6 SP Howitzers and M992-Series Ammo Carriers . . .

Snub of a Grease Fitting

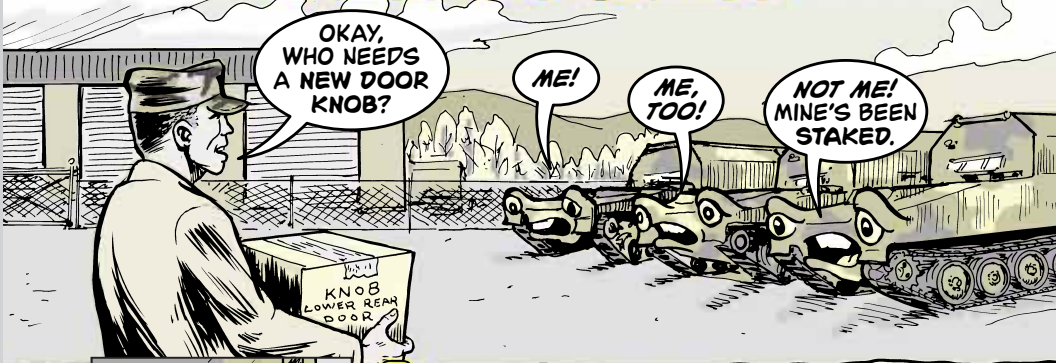
Crewmen, a loose door knob on your M992-series ammo carrier will often turn into a missing one. Vibration is the culprit.

During operation, the lower rear door knob, NSN 5355-01-183-8387, slowly vibrates loose from the quick release plunger holding it in place. Every time a knob gets lost, you're out another \$14.

So, keep that knob on the job. After you screw the knob tightly in place, stake the end of the plunger by separating or bending the threads slightly with a cold chisel and hammer. Then, even though the knob might loosen, it can't fall off.

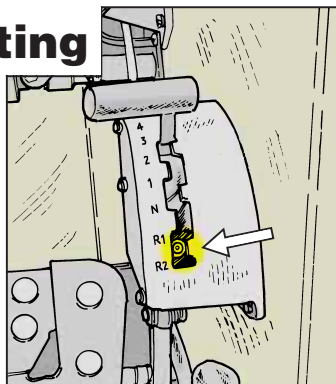
Operators, the gear shift selector grease fitting on M109A2-A6 SP howitzers and M992-series ammo carriers was left out of the lube order in your manuals.

Without lube, the shifter gets tight and hard to shift.

So, keep the selector lubed. During scheduled services, give the fitting four to five pumps of grease. Make a note until the service is added to TM 9-2350-293-10, -311-10 and -314-10.
